# SL SHOP (Sales & Service) Ltd

# Vehicle Health Check

Make Mercedes-Benz  
Model SL Class  
Registration JAZ8187  
Chassis No WDB1070472A061109  
Mileage 135480

8170

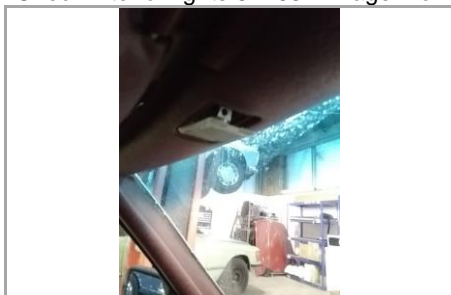
Check interior lights 82165 - Image 1 of

Comments / Recommendations		Net	VAT	Total	
<b>Initial Road Test 00IRT</b>					
A	Engine performance / smoke / noises	Engine idles very lumpy and belts squeak when driving			
A	Brake performance / spongy / pulling left or right	Brake pedal feels very hard like a possible seized caliper			
A	Steering in straight position / feel / noises	Steering wheel off centre and there's play in the steering box			
A	Check operation of warning lights 54585	Washer light inop			
G	Check operation of wipers and washers 86000				
G	Check operation of horn 54105				
G	Check operation of parking brake 42120				
<b>lights 82000</b>					
R	Check operation of front external lights 82195	NS fog light inop			
R	Check operation of rear external lights 82225	OS side light inop			
<b>Interior 91000</b>					
G	Check seat and seat belt operation 91090				
R	Check interior lights 82165	Header rail lights inop and passenger light is hanging off

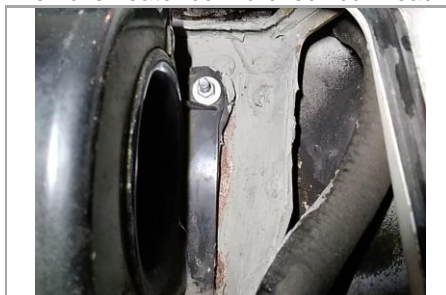
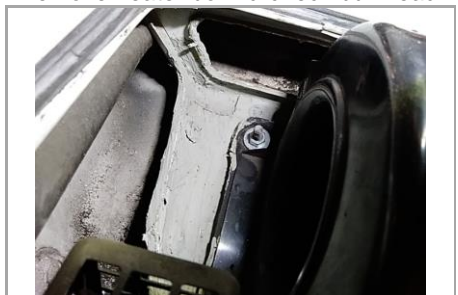
G	Heater motor operation 83135				
R	Radio and aerial operation 82345	Radio and aerial works but doesn't pick up any stations			
<b>Engine Bay 18000</b>					
G	Antifreeze strength 50000	Up to -23c			
R	Remove heater box lid-check bulkhead 62015	Bulkhead has been previously poorly repaired with seam sealer and riveted plates ontop			
G	Check battery condition 54080				
G	Check charging Volts 15030	13.7 volts			
G	Check G/Box oil level 18000				
G	Check engine oil level / condition 18000				
G	Check for fuel leaks 07075				
A	Check brake fluid level / condition 42000	Boiling point is 165 minimum is 155			
<b>Under Vehicle 00UV</b>					
A	Check drop links 32060	Front anti roll bar bushes extremely perished but no knocking			
R	Check front wishbones 33030	Passenger wishbone is heavily corroded resulting in 2 holes			
G	Check shock absorbers 32000				
G	Check engine mountings 22010				
G	Check subframe bushes 33010

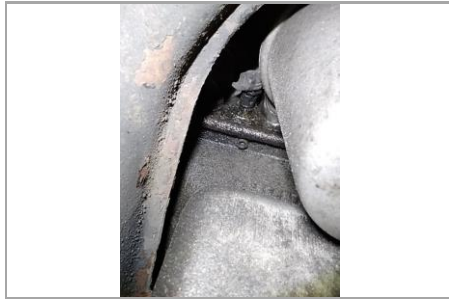
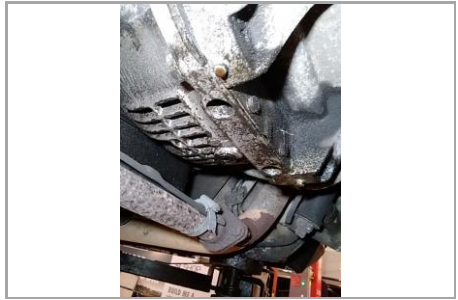
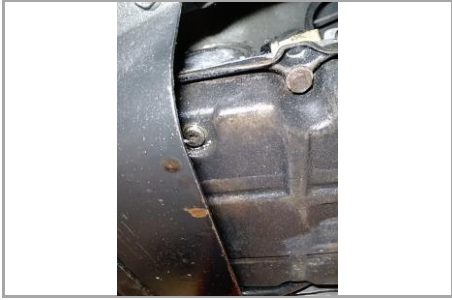
Check for general oil leaks 18000 -

R	Check for general oil leaks 18000	Possibly sump leaking. Rear main seal leaking. Gearbox leaking			
G	Check propshaft couplings condition 41015

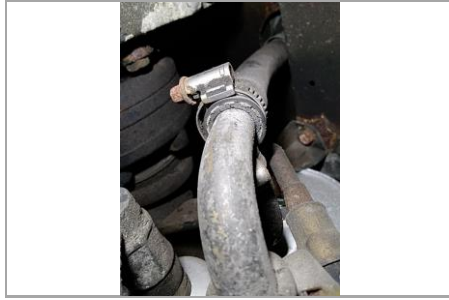
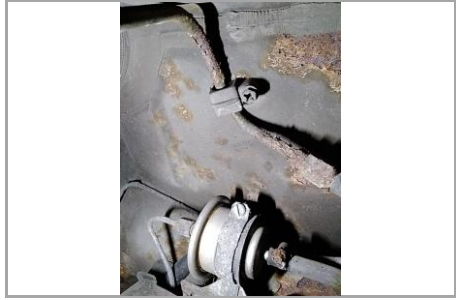
Check fuel pump pipes/filter package 47045 - Image 1 of 2

Comments / Recommendations		Net	VAT	Total	
<b>R</b>	Check fuel pump pipes/filter package 47045	Main fuel line extremely corroded and may leak soon. All rubber hoses are perished and rock hard.			
<b>A</b>	Check exhaust system condition 14060	Backbox heavily corroded and blowing slightly.			
<b>A</b>	General underbody corrosion / Waxoyl 61000	Heavy corrosion present inside OS chassis leg underneath where the ABS pump is. Heavy corrosion present inside NS chassis leg. Corrosion present on drivers chassis rail meets chassis leg. Corrosion present on both rear arch to boot floor. Corrosion present on rear seat bases.			
<b>A</b>	Visual check on brake pads and discs 42000	Both rear pads are crumbling and discs are corroded. OSR wheel difficult to turn, possibly seized caliper			
<b>G</b>	Check rear drive shafts/boots 35030				
<b>R</b>	Wheel bearings	Both front bearings have play but NS his extremely noisy

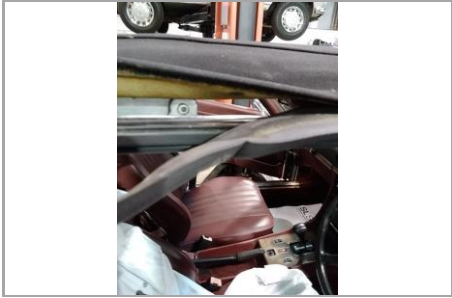
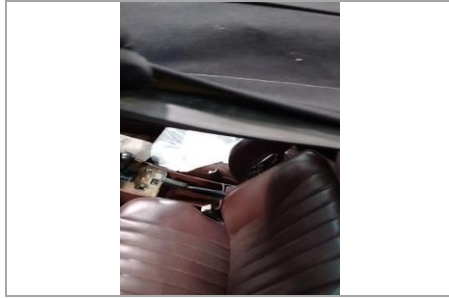
Check soft top open/closure/catch  
mechanism 7700 - Image 1 of 2

<b>Soft Top Check 77000</b>					
<b>A</b>	Check soft top open/closure/catch mechanism 7700	Release cable needs adjusting. Upper window seals not attached on both sides.			
<b>Water Test 00WT</b>					
<b>R</b>	Check bulkhead for leaks	Bulkhead leaking onto both drivers and passenger foot wells			
<b>R</b>	Check window/door seals for leaks	Both hardtop seals allowing water ingress onto the seats			
<b>G</b>	Check boot/rear lights for leaks				
		<b>Total</b>	0.00	0.00	0.00

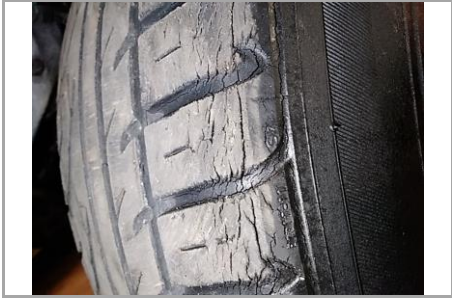
Tyres	Tread (mm)	Manufacturer	Size	Comments/Recommendations
<b>G</b> N/S Front	5.5			
<b>G</b> N/S Rear	6.0			
<b>G</b> O/S Front	5.5	5.5		Tyre is extremely perished all over the tyre
<b>G</b> O/S Rear	6.0			
<b>G</b> Spare	4.0
