SL SHOP (Sales & Service) Ltd

Vehicle Health Check

Make Mercedes-Benz
Model 350
Registration EGY313T
Chassis No 10704322014062
Mileage

Date 2022-09-29
Service Advisor
MOT Due 09/05/2022
Inspected By m - Marek

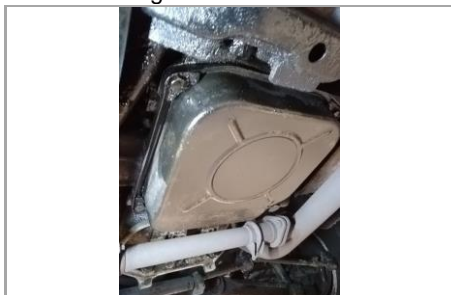
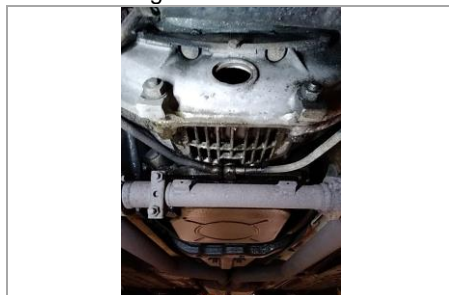
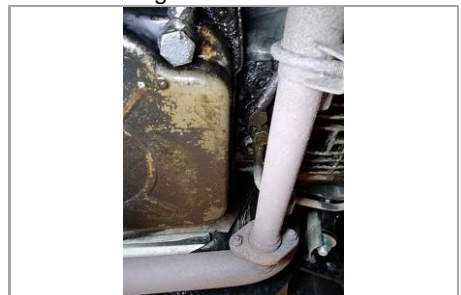
G	Check charging Volts 15030			
G	Check G/Box oil level 18000			
G	Check engine oil level / condition 18000			
G	Check for fuel leaks 07075			
A	Check brake fluid level / condition 42000	Bit dark		
Under Vehicle 00UV				
A	Check drop links 32060	Both perish and have play		
G	Check front wishbones 33030			
G	Check shock absorbers 32000			
G	Check engine mountings 22010			
G	Check subframe bushes 33010			
A	Check for general oil leaks 18000	Gearbox leaks not massive but it's wet as on the pictures. One leak I can see come from propshaft oil seal.		
G	Check propshaft couplings condition 41015

Check for general oil leaks 18000 -

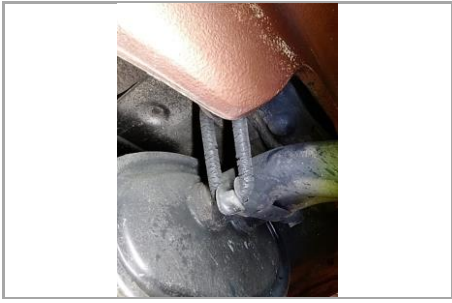
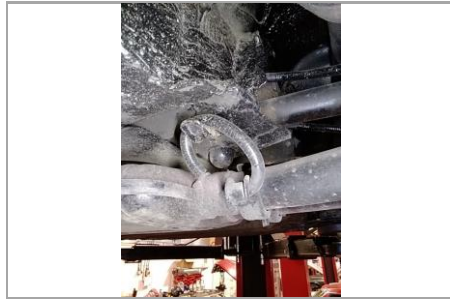
Comments / Recommendations		Net	VAT	Total
G	Check fuel pump pipes/filter package 47045			
A	Check exhaust system condition 14060	Middle box rubber snap End box one rubber is perished and on the edge to snap.		
A	General underbody corrosion / Waxoyl 61000	Both sides of kick panel to floor badly corroded. Rear O/S arch badly corroded		
G	Visual check on brake pads and discs 42000			
G	Check rear drive shafts/boots 35030			
Soft Top Check 77000				
G	Check soft top open/closure/catch mechanism 7700			
Water Test 00WT				
G	Check bulkhead for leaks			
A	Check window/door seals for leaks	Both sides leaking slightly		
A	Check boot/rear lights for leaks	Leaking and not only on the side seal badly fitted		
		Total	0.00	0.00
			0.00	0.00

Check exhaust system condition
14060 - Image 1 of 2

Check exhaust system condition 14060 -
Image 2 of 2

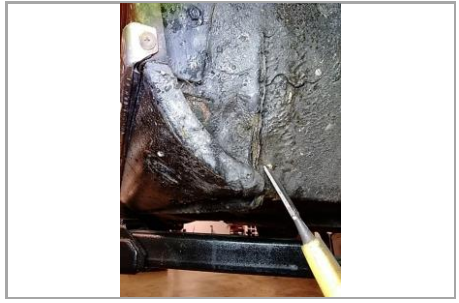
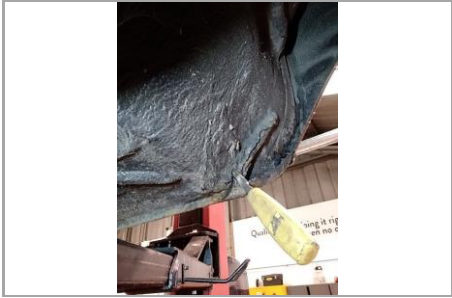
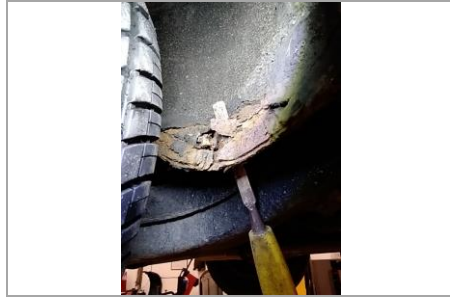
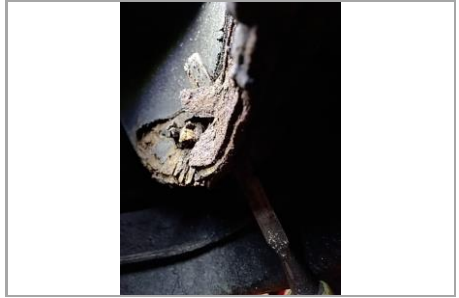
General underbody corrosion / Waxoyl
61000 - Image 1 of 4

General underbody corrosion / Waxoyl
61000 - Image 2 of 4

General underbody corrosion / Waxoyl
61000 - Image 3 of 4

General underbody corrosion / Waxoyl
61000 - Image 4 of 4

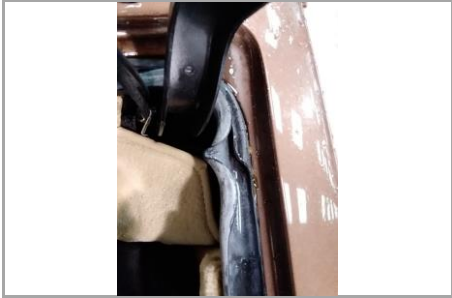
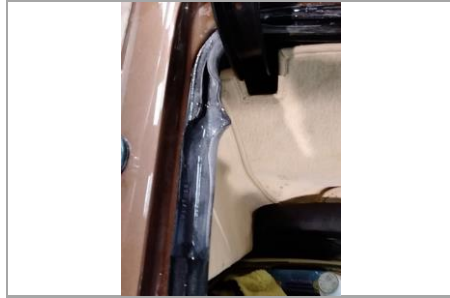
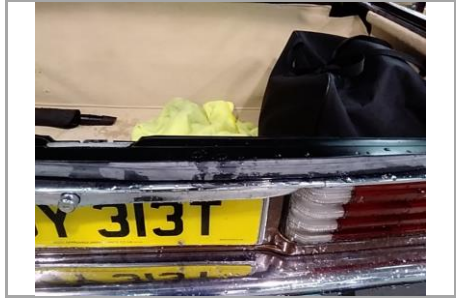
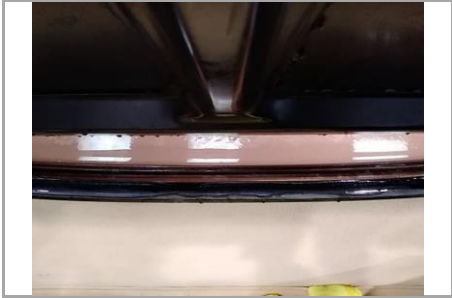
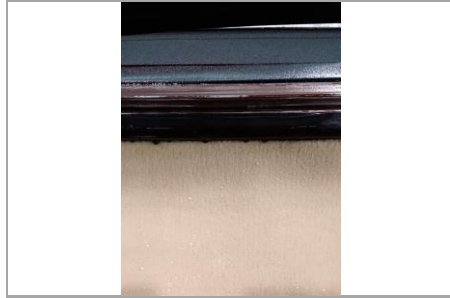
Check boot/rear lights for leaks - Image
1 of 5

Check boot/rear lights for leaks - Image
2 of 5

Check boot/rear lights for leaks - Image
3 of 5

Check boot/rear lights for leaks - Image
4 of 5

Check boot/rear lights for leaks - Image
5 of 5
