# SL SHOP (Sales & Service) Ltd

# Vehicle Health Check

Make Mercedes  
Model SI/Sec Series  
Registration F327EAX  
Chassis No WDB1070412A085900  
Mileage

Date 2022-10-06  
Service Advisor Russell Owens  
MOT Due 13/06/2023  
Inspected By m - Nathan Wheeler

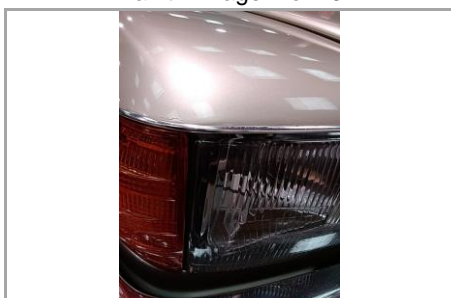
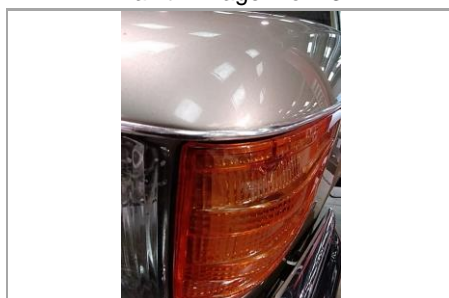
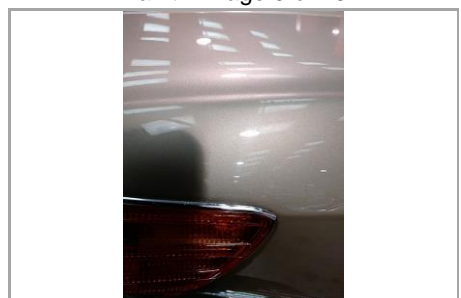
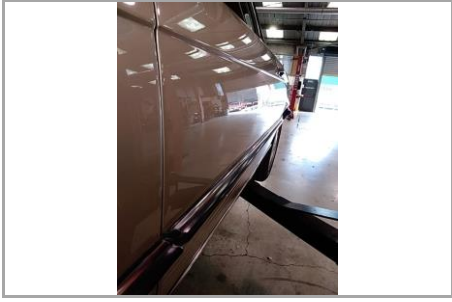
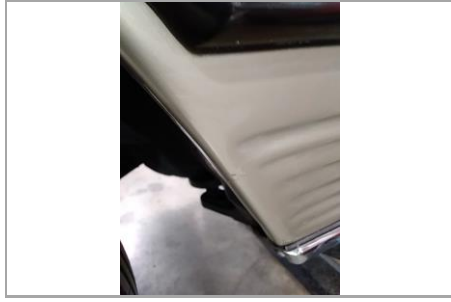
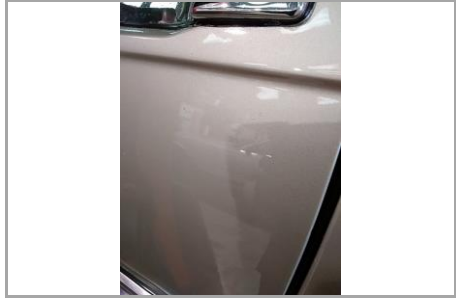
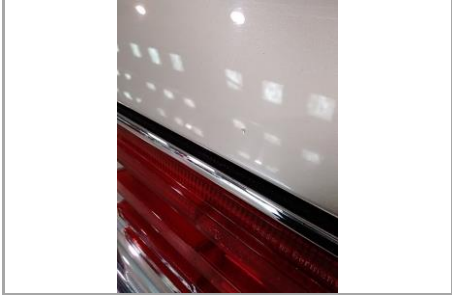
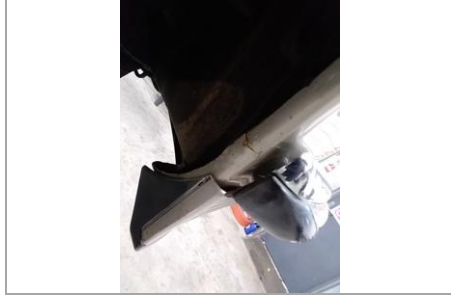
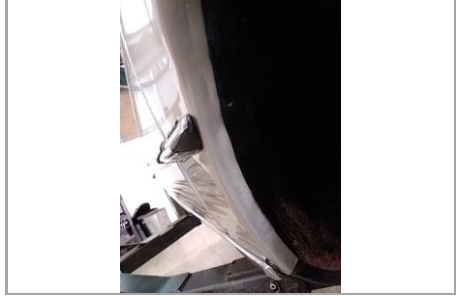
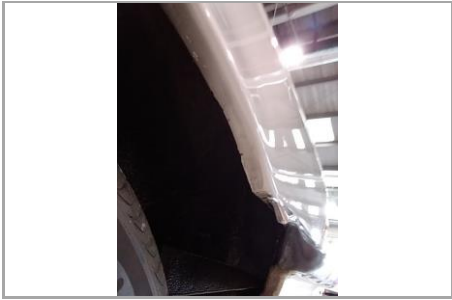
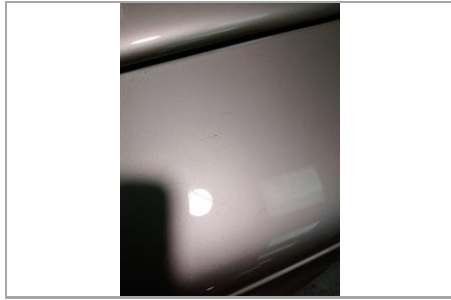
Comments / Recommendations		Net	VAT	Total
<b>EXTERIOR</b>				
A	Bodywork	Passenger door is abit wavy and the rear arch seems to have filler in it		
A	Paint	Marks in paint above chrome eyebrows A few marks over the car Seems to be filler in the some archs and possibly the door as it's very wavy(passenger door)		
A	Trim	Numberplate chrome fitted incorrectly Rear bumper needs adjustment  Rear bumper rubber isn't fitted correctly Sills chromes are dented Rear quater moulding appear to be stuck on and broken Front bumper chrome bubbling Front bumper rubbers have marks on themGrill rubber incorrectly fitted		
G	Glass			
A	Chrome	Marks on various chromes around the car		
A	Underbody	Arch liners fitted incorrectly Evap tank pipe split Surface corrosion in various places under the car would advise clean down treat and wax oil  Both front wheel bearings require adjustment		
R	N/s/r wheel bearing	Excessive play mot fail
