SL SHOP (Sales & Service) Ltd

Vehicle Health Check

Make Mercedes-Benz
Model SL Class
Registration E818FRO
Chassis No WDB1070412A074717
Mileage 125300

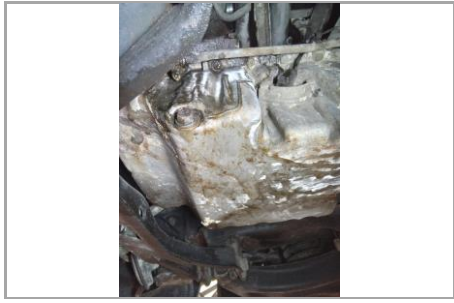
Check for general oil leaks 18000 -
Image 2 of 2

G	Check seat and seat belt operation 91090			
R	Check interior lights 82165	Interior lights dotn work		
G	Heater motor operation 83135			
G	Radio and aerial operation 82345			
Engine Bay 18000				
R	Antifreeze strength 50000	Anti freeze level is really low but the strength is OK and able to reach -23		
A	Remove heater box lid-check bulkhead 62015	Surface corrosion on the bulkhead		
G	Check battery condition 54080			
G	Check charging Volts 15030	12.5		
G	Check G/Box oil level 18000			
G	Check engine oil level / condition 18000			
G	Check for fuel leaks 07075			
G	Check brake fluid level / condition 42000	Dot 3/4 at 320 degrees c		
Under Vehicle 00UV				
A	Check drop links 32060	Slight play on the O/S drop link on the rear		
G	Check front wishbones 33030			
G	Check shock absorbers 32000			
G	Check engine mountings 22010			
G	Check subframe bushes 33010			
A	Check for general oil leaks 18000	Seems to be an old leak from the gear box and gear box sump pan need further investigation to confirm. Same with the sump slight leak but need further investigation

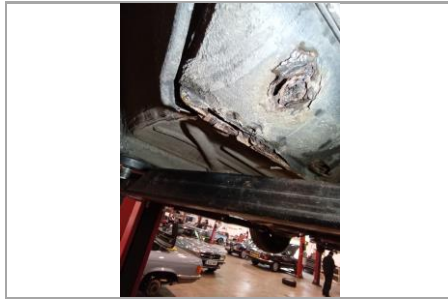
General underbody corrosion / Waxoyl
61000 - Image 1 of 4

Comments / Recommendations		Net	VAT	Total
G	Check propshaft couplings condition 41015			
A	Check fuel pump pipes/filter package 47045	Fuels pipes staring to look worn may need replacing In the future		
G	Check exhaust system condition 14060			
A	General underbody corrosion / Waxoyl 61000	No wax oil the is corrossion in areas of the underbody on the sills on both sides of the car		
G	Visual check on brake pads and discs 42000	Brakes are a good thickness O/S rear has worn down more the near side rear to 6mm		
G	Check rear drive shafts/boots 35030			
Soft Top Check 77000				
G	Check soft top open/closure/catch mechanism 7700			
Water Test 00WT				
G	Check bulkhead for leaks			
G	Check window/door seals for leaks			
G	Check boot/rear lights for leaks			
Total		0.00	0.00	0.00
