Vehicle Health Check

Make Mercedes-Benz
Model SL Class
Registration LHH3
Chassis No WDB1070472A086723
Mileage 64711

Date 2023-03-20
Service Advisor Russell Owens
MOT Due 19/01/2024
Inspected By m - Matt Clarke

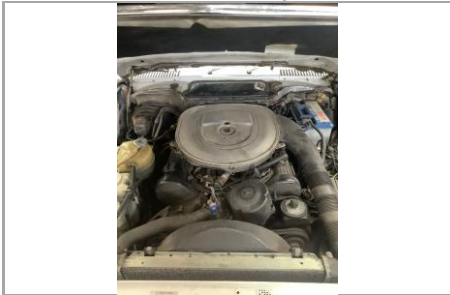
Appearance - Image 1 of 1

G	Dash				
G	Carpets				
A	Boot carpet	It carpet is soaking wet as the is a lot of water getting into the boot.			
ENGINE					
A	Appearance	Dusty and corrosion. Possible power steering leak.			
R	Starting	Will not start unless it is jump started.			
A	Running	Poor running when warm. car seems to run lumpy and is hunting on idle.			
A	V belts	Front v belts all showing signs off age and wear			
A	Under bonnet	Under bonnet sound deadening in poor and coming away			
TRANSMISSION					
G	Gear change	On initial test drive vehicle changes gear nicely. But hard to get kick down on our drive.			
G	Propshaft/Driveshafts				
A	Car wonders	Car wonders to right more so under braking.			
A	Noise on full lock	Noise/ vibration slight on full lock sounds like o/s/f			
RUNNING GEAR					
A	Axles	All bushes are showing signs of age.Front subframe bushes are showing signs of cracking as well as lower arm bushes.			
A	Suspension	All suspension components have surface rust
