SL SHOP (Sales & Service) Ltd

Vehicle Health Check

Make Mercedes-Benz
 Model SL Class
 Registration R751PSH
 Chassis No WDB1290632F166864
 Mileage

Date 2023-05-19

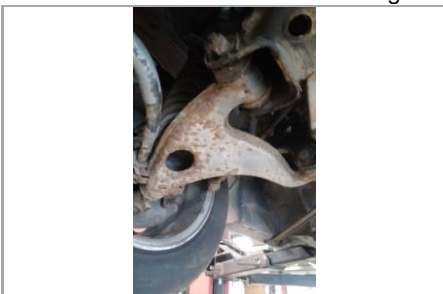
Check front wishbones 33030 - Image 1

| Comments / Recommendations | | Net | VAT | Total |
|---|--|---|---|---|
| A | Check front wishbones 33030 | Heavily corroded | | |

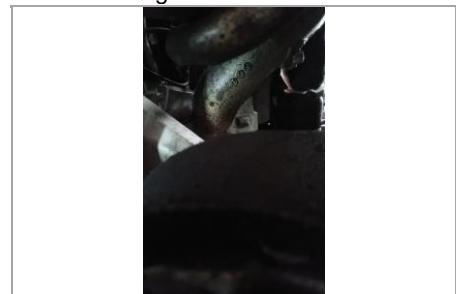
Check for general oil leaks 18000 -

| Comments / Recommendations | | Net | VAT | Total |
|---|--|---|---|---|
| A | Check for general oil leaks 18000 | Leaking around front timing seal and oil present around intake manifold | | |

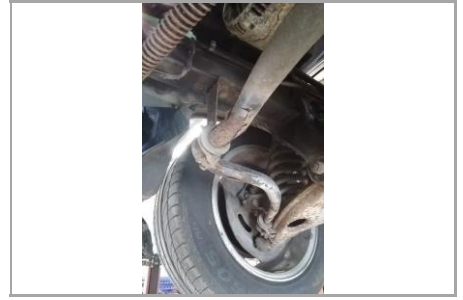
General underbody corrosion / Waxoyl
61000 - Image 1 of 7

| Comments / Recommendations | | Net | VAT | Total |
|---|--|---|---|---|
| A | General underbody corrosion / Waxoyl 61000 | Heavily corroded everywhere just covered on the floor pans with black wax | | |

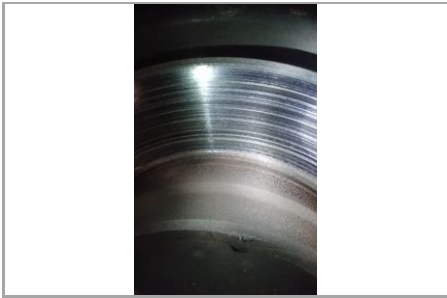
Visual check on brake pads and discs
42000 - Image 1 of 2

| Comments / Recommendations | | Net | VAT | Total |
|---|--|---|---|---|
| A | Visual check on brake pads and discs 42000 | Rear discs are heavily scored | | |
